# Manhole Inspection Summary

Manhole # S11Y\_\_018MH

Insp Date: **4/7/08 11:36 AM**

**Location** Address: **3401 Benson Ave**

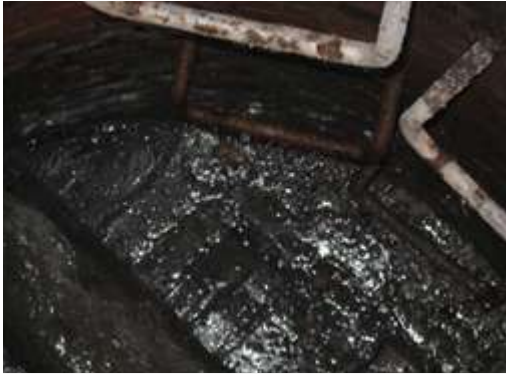
Defect 1

**Steps** Count: **4** Missing: **0** ☒ **Corroded**

Corroded steps

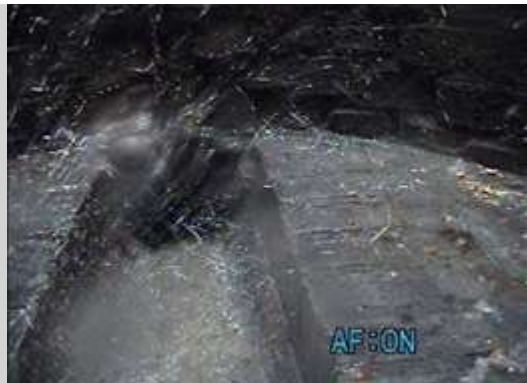
6 O'Clock Inflow

Pipe Height: **8.4** (in.) Rod and Bar (Angled)  
Pipe Material: **PVC** ☐ Pipe Lined  
Invert Depth: **12.29** (ft.) Flow Characteristics: **Fast**  
Deposits: ☒ None ☐ Mud ☐ Sludge ☐ Debris ☐ Grease  
Silt Depth: **0** (in.) Deposits Extent:  
Infiltration: **Evidence** Pipe Seal Cond: **Unknown**

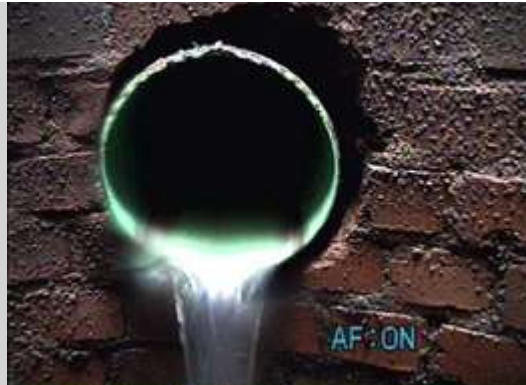
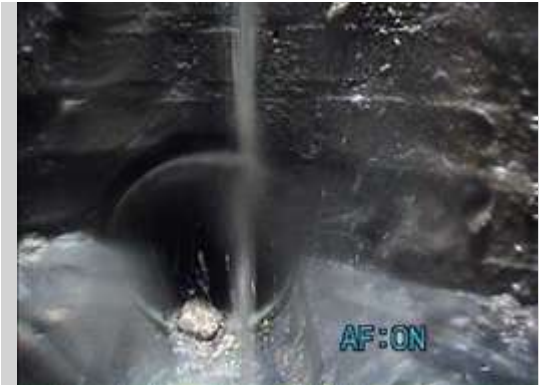
8 O'Clock Inflow

Infiltration: **Evidence** Pipe Seal Cond: **Unknown**

Drop: **Inside**

Drop Condition: **Open**
